The Design and Operation of a Passive Humidity-Controlled Cold Storage Vault Using Conventional Freezer Technology and Moisture-Sealed Cabinets

Mark McCormick-Goodhart and Henry Wilhelm Wilhelm Imaging Research, Inc., Grinnell, Iowa/USA Presented at the IS&T Archiving Conference, San Antonio, Texas, April 22, 2004

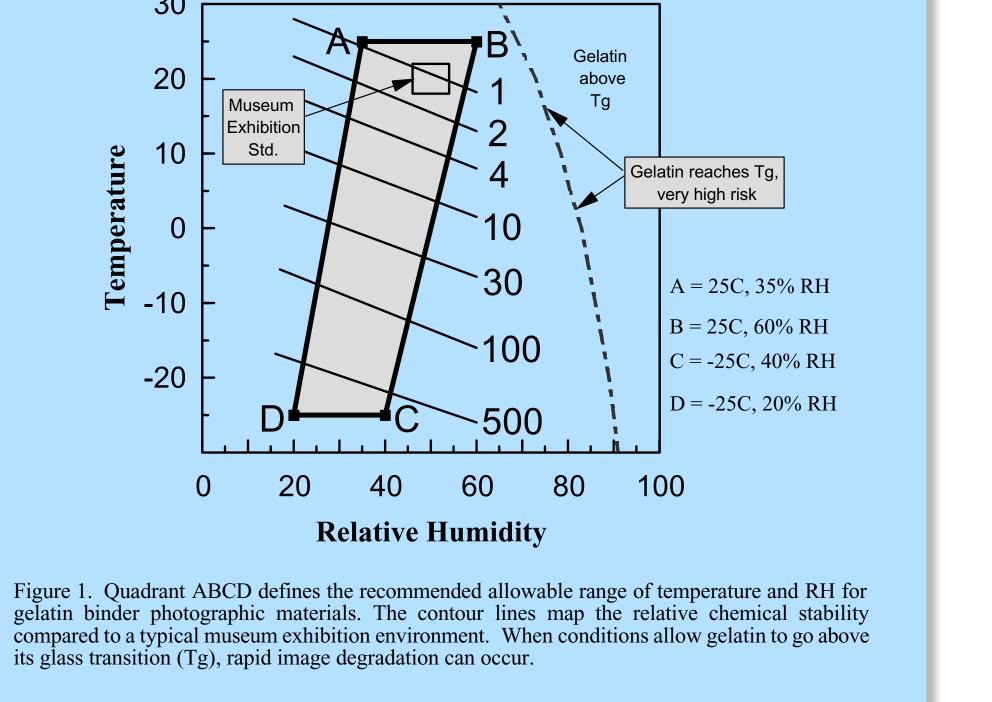
The sealed cabinet method takes advantage of the natural thermodynamic

properties of hygroscopic materials such as gelatin and paper to keep the climate inside the cabinets within the safe, allowable range as shown in the figure above. For more information about this topic please read the paper entitled: "The Allowable Temperature and Relative Humidity Range for the Safe Use and Storage of Photographic Materials," Journal of the Society of Archivists, Vol. 17, No. 1, 1996. It is available for free on our website:

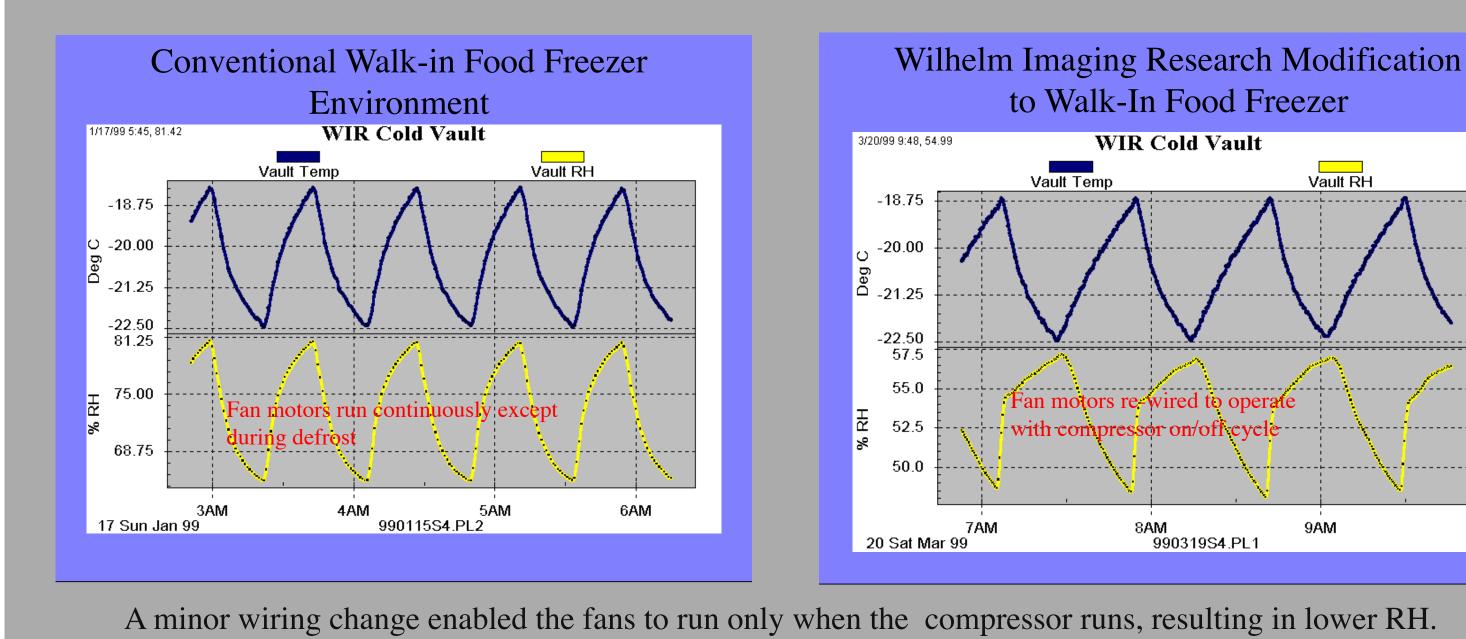
A minor wiring change enabled the fans to run only when the compressor runs, resulting in lower RH.

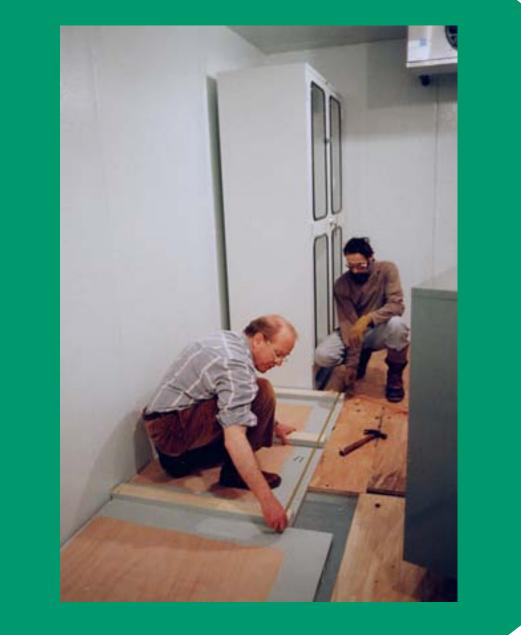
The dimensions of the vault were planned so that cabinets would fit through the door, and equally important, could be erected vertically once inside the vault. Note the 4 to 6 inch clearance left between the cabinets and the inside wall of the vault (see photo on the far right). This gap improved air circulation and cabinet temperature uniformity.

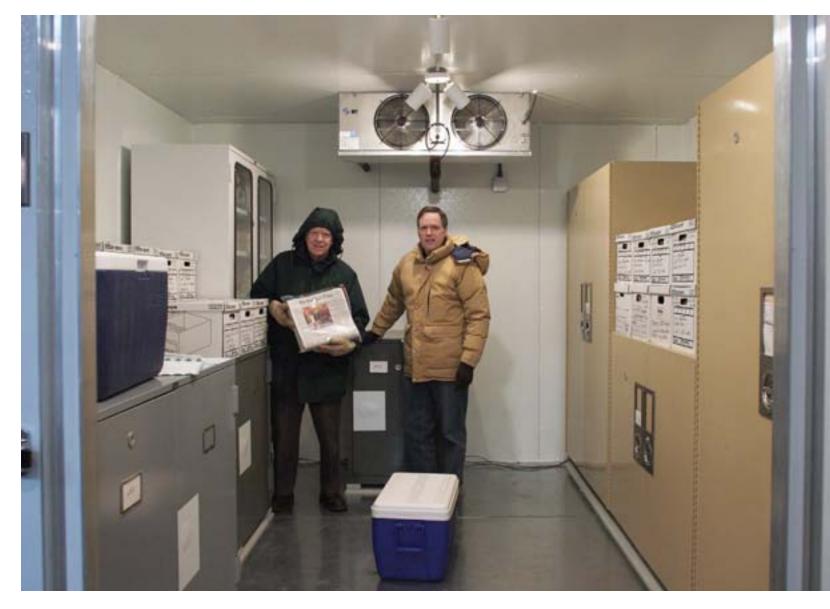
Bringing objects safely in and out of the vault was accomplished by thermally insulated transfer boxes. Shown above is one that was made from an ordinary picnic cooler. A radio transmitting temperature sensor (available at RadioShack® for less than \$40.00) is a simple way to determine when the box may be safely opened. We con-
