## The Design and Operation of a Passive Humidity-Controlled Cold Storage Vault Using Conventional Freezer Technology and Moisture-Sealed Cabinets

Mark McCormick-Goodhart and Henry Wilhelm Wilhelm Imaging Research, Inc., Grinnell, Iowa/USA Presented at the IS&T Archiving Conference, San Antonio, Texas, April 22, 2004

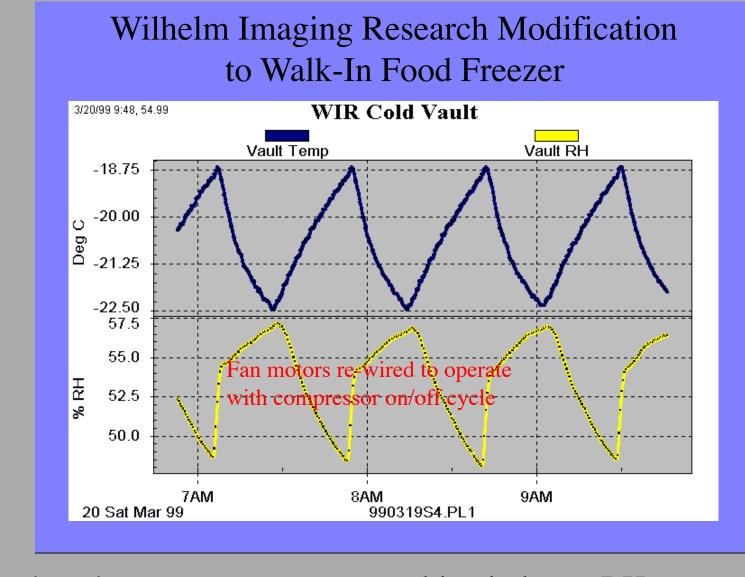
A minor wiring change enabled the fans to run only when the compressor runs, resulting in lower RH.

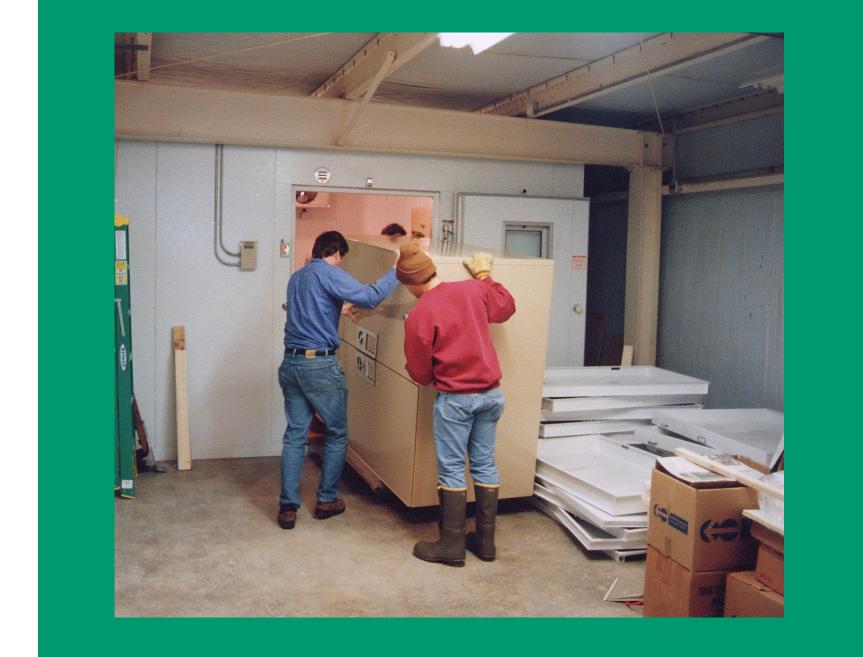
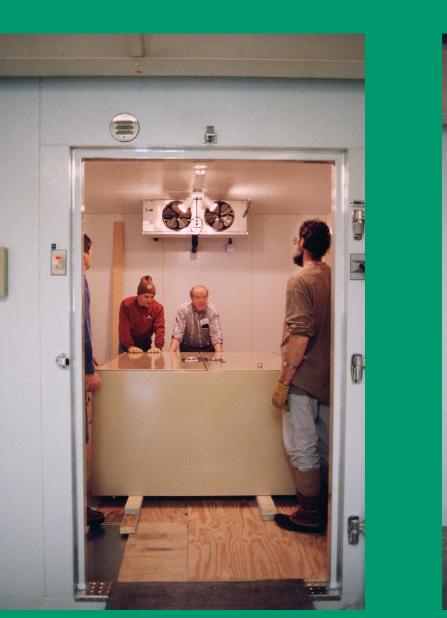
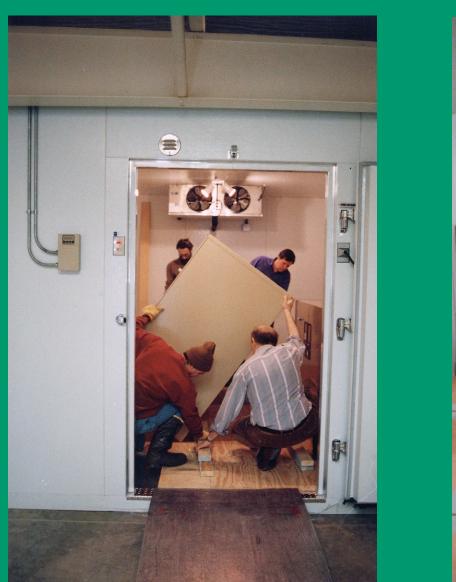
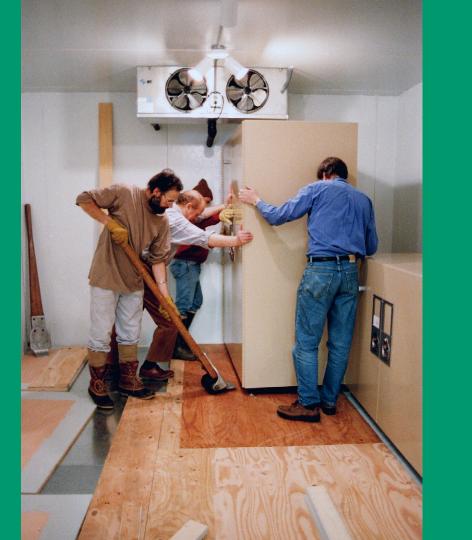
the heated slab was not necessary.

Walk-in freezers are readily available due to their wide-spread use in the food

industry. Modular construction allows quick assembly. Site preparation for our

project was minimal. We checked with the contractor to determine whether a

heated slab would be needed under the freezer to prevent frost heaving. Because

our vault was located in a fully heated building and away from the outer walls,

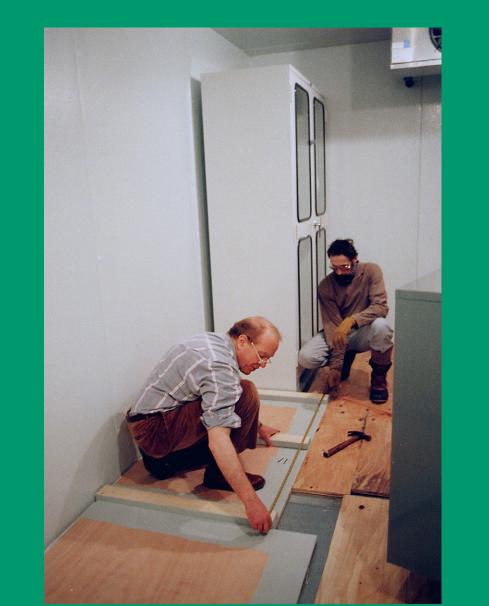
The dimensions of the vault were planned so that cabinets would fit through the door, and equally important, could be erected vertically once inside the vault. Note the 4 to 6 inch clearance left between the cabinets and the inside wall of the vault (see photo on the far right). This gap improved air circulation and cabinet temperature uniformity.

... Time to Complete — 1 day

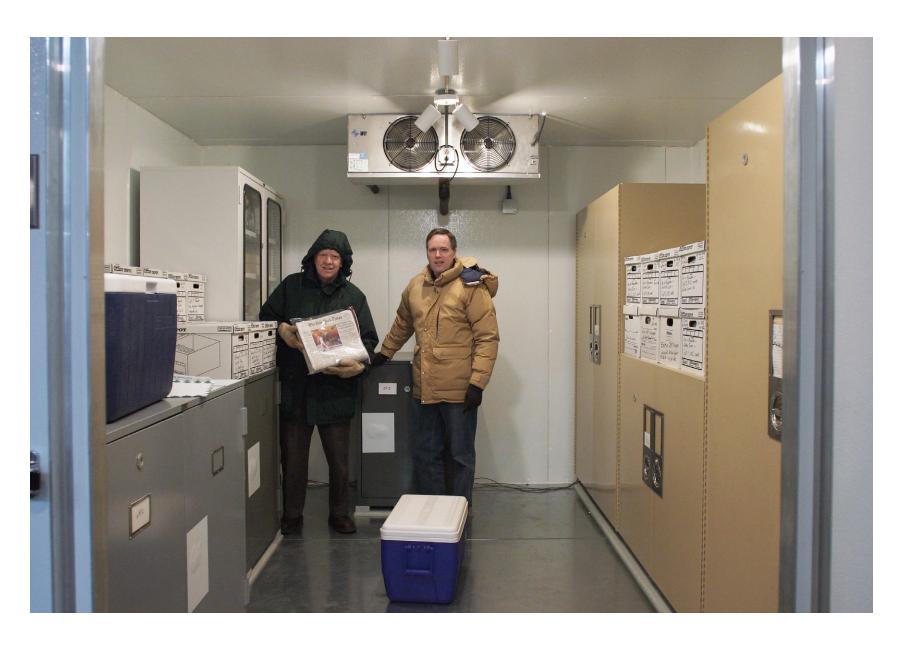
Bringing objects safely in and out of the vault was accomplished by thermally insulated transfer boxes. Shown above is one that was made from an ordinary picnic cooler. A radio transmitting temperature sensor (available at RadioShack® for less than \$40.00) is a simple way to determine when the box may be safely opened. We con-

ducted thermal staging experiments to prove the safety and efficacy of the method.
